An Assessment of Burdur Lake Ramsar Site (Türkiye)

Burdur Lake and its surroundings, one of the 14 Ramsar sites in Türkiye, need urgent protection measures and rehabilitation. This study covers the field observations we have made on the area since 2013. The article was prepared to draw attention to Burdur Lake, which has been drying up in recent years, and to create environmental awareness among the local people. Flora and fauna are rich in its terrestrial ecosystem. Due to these important features, Burdur Lake was included in the Ramsar sites with 25,096.00 ha on 13.07.1994. In recent years, around 25 agricultural dams have been built on the streams feeding this lake, completely ending the natural water input. The construction of these dams was after the 2010s. In 2012, the natural feeding of the lake completely stopped. With the dams built, the lake's water resources spread over a wide area, evaporation, absorption and the precipitation gradually decreased, and the lake is in danger of drying up. There is no other source of nutrition for the lake other than the waste and polluted water of the Organized Industrial Zone and Burdur city center, which are shown as purified. Recently

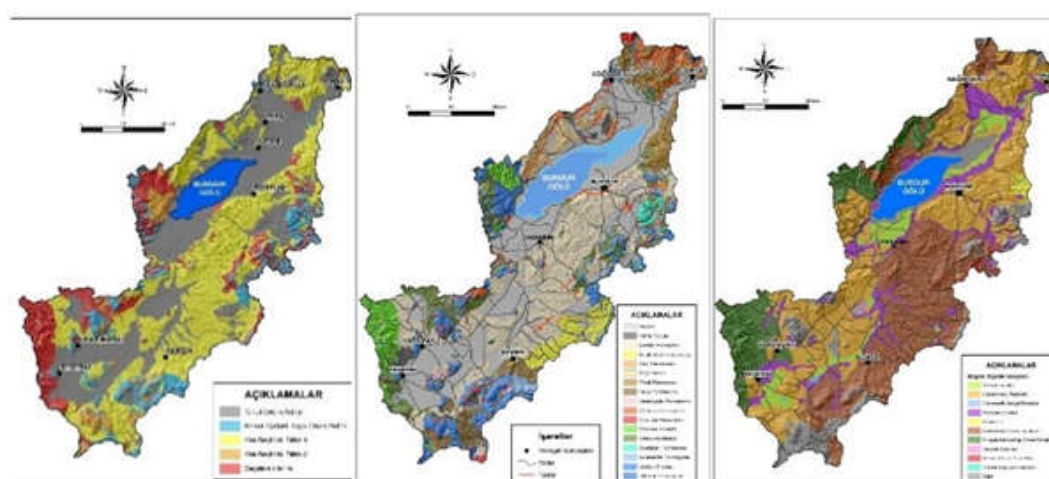
Figure 2: Hydrogeology and hydrology maps of Burdur Lake basin (Gülle et al., 2018).

According to Korkuteli meteorological station measurements; average monthly precipitation for years 1970-2017 is 30.4 mm³. Accordingly, the least precipitation is 10 mm and below in July, August and September, and the most precipitation is 48.97 mm³ and 47.32 mm³ in January and December. Dry between 1971-1973 years; rainy between 1974-1988; dry again between 1989-1993; stable between 1994-2000; rainy between 2000-2004; after a 9-year dry period from 2004, rainy until 2015, and a dry period again after 2015. According to the last measured long-term monthly precipitation data, the average monthly precipitation is 34.6 mm³. Accordingly, the minimum precipitation was measured in August with 9.4 mm³, and the maximum precipitation was measured in December with 51.7 mm³. It was determined that quite high precipitation values were measured in January (49.6 mm³) and April (47.7 mm³). In July (15.3 mm³) and September (16.5 mm³), precipitation values were recorded at quite low levels. Due to drought, the monthly average evaporation value is 166.8 mm³, and evaporation occurs above average in June, July and August (Gülle et al., 2018). Figure 2.

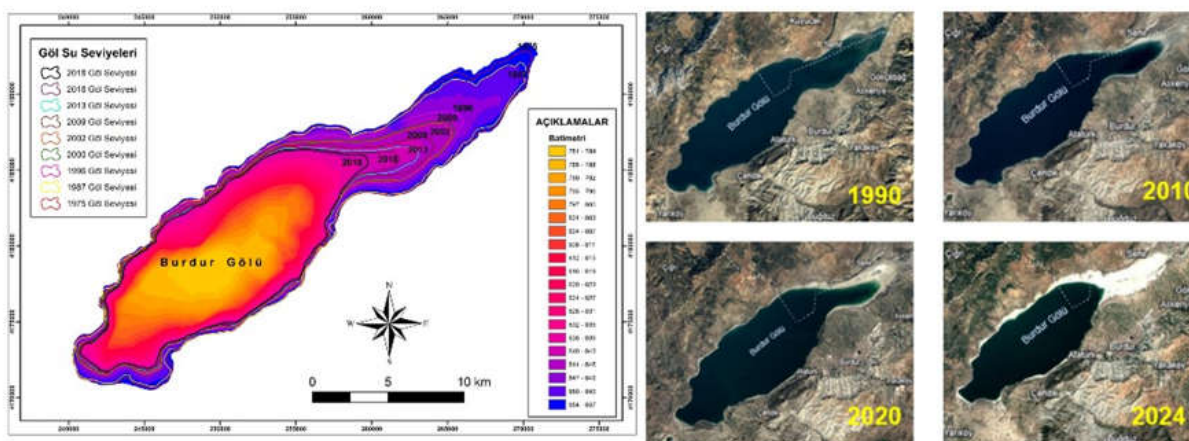
Figure 3: Change in the surface area of Burdur Lake over the years (from Google Earth; Gülle et al., 2018).

The most important reason for the retreat of the lake is the dams built on the streams coming to the lake. The water collected in these dams is generally used for agricultural irrigation. It was determined in the field studies carried out in the basin that there is no surface flow reaching the

lake specially after 2012, This situation is an indication that the streams whose flow rate decreases due to the collection of water in dams for irrigation purposes dry up and do not reach the lake at all (Anonymous, 2012). Figure 3.

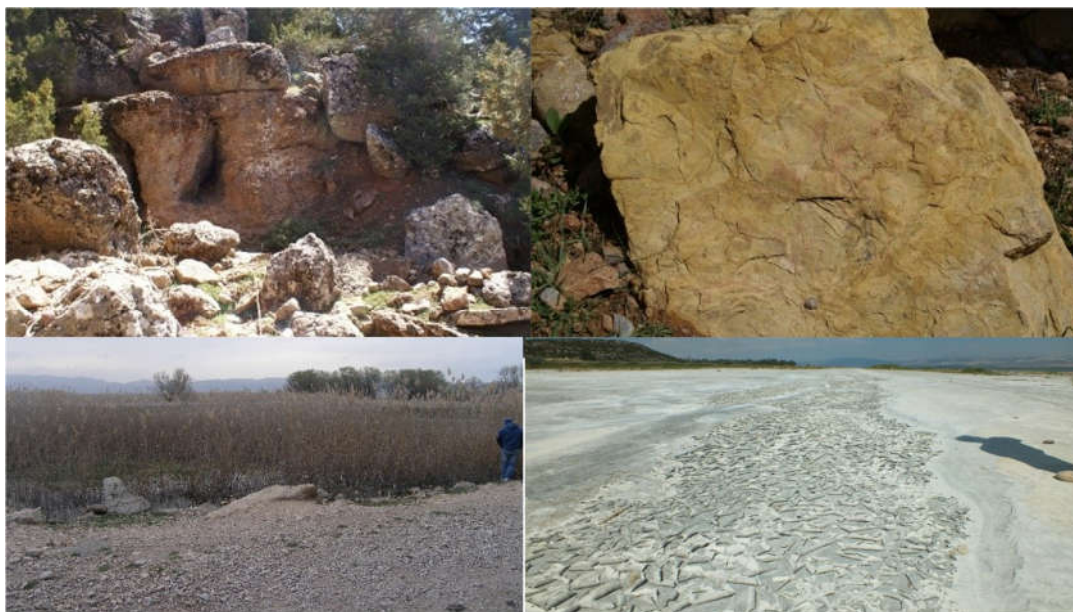
Figure 4: The main rocks of the Burdur Lake basin: conglomerate, limestone, sandstone, saltstone and sulfur beds.

Arsenic is formed from sulfur beds, salt from salt beds and clay from limestone. General geological structure of the land is conglomerate and is permeable to water. When the clay layers formed by limestone rocks dry, a thin layer forms on it. It is turned into dust by grazing animals and other factors and is blown to the environment by the wind.

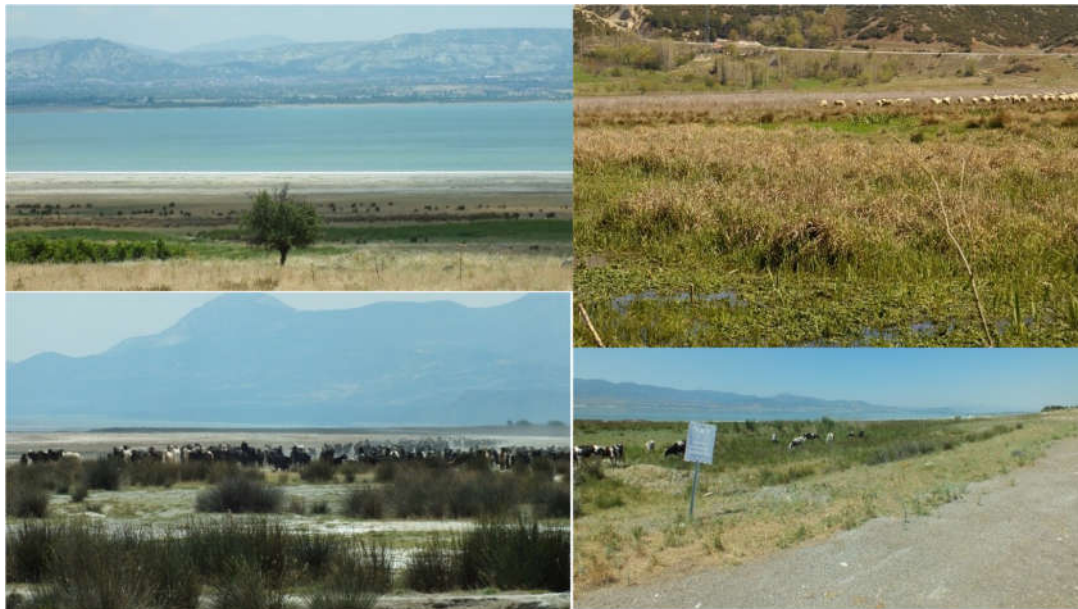
Figure 6: As the water level around Burdur Lake has decreased, the area has turned into meadows and pastures, making it a suitable environment for animal husbandry. For this reason, animal producers in the area seem happy with the lake's withdrawal for now.

According to the study of Atılgan et al. (2006); animal husbandry is the main source of income in Burdur province. The amount of manure in animal husbandry enterprises is very high. Improper storage of manure damages the environment and the lake. When phosphorus secreted from manure mixes with water

resources, algae develop and this reduces the amount of oxygen in aquatic habitats and increases the mortality rate in fish populations. This negatively affects the biodiversity and water quality of the lake. For this, an ecological purification system is needed. Figure 6, 7.

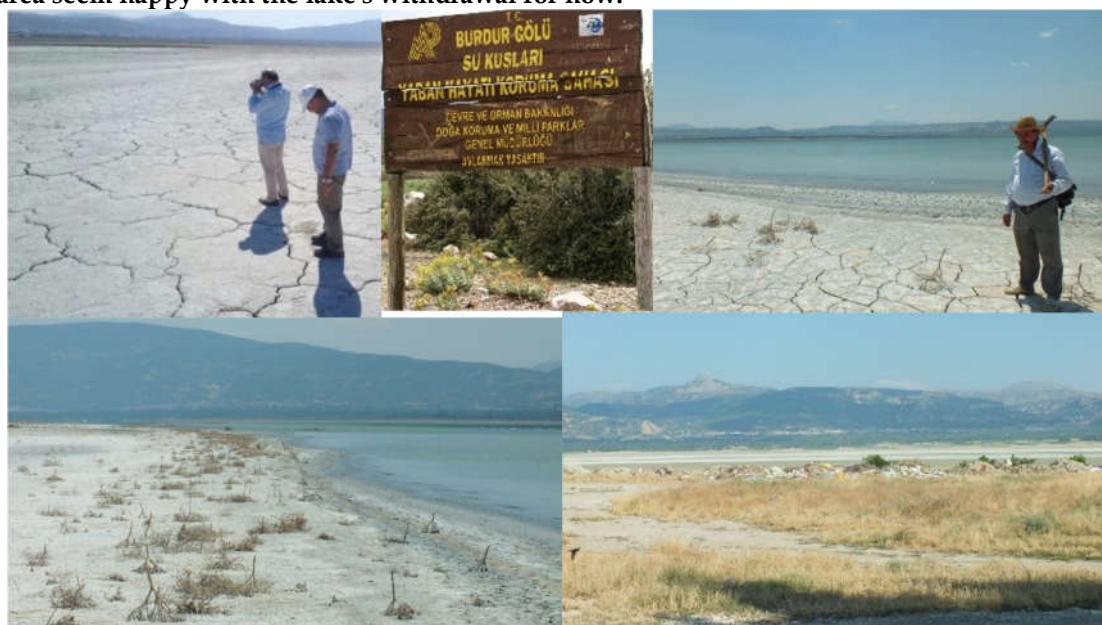
Figure 7: As the water in Lake Burdur recedes, swampy areas turn into steppes, thorny and poisonous plants that animals do not eat dominate the vegetation; or the area remains bare.

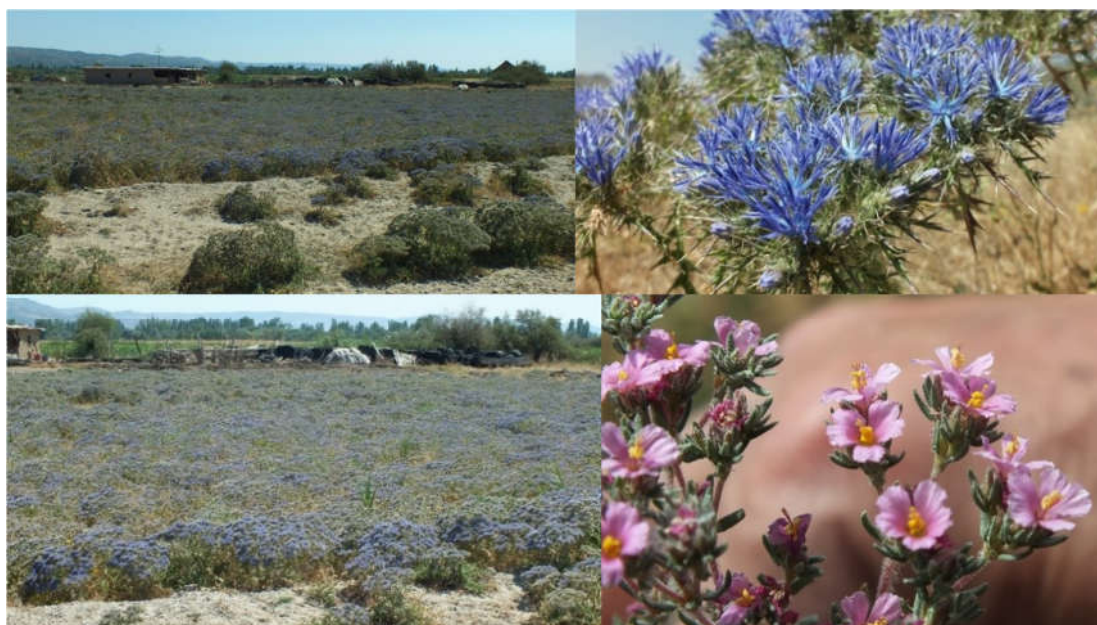
Figure 8: As a result of overgrazing around Lake Burdur, *Cordopathyum corymbosum*, a thorny plant, has become dominant in the area; populations of *Frenkenia hirsuta* (in bottom right) have been severely damaged by field clearings.

Excessive grazing and mowing are carried out in the surrounding area. This situation increases the plant species resistant to grazing and mowing; suppresses non-resistant species. The weakening of the vegetation disrupts the shelters and habitats of wild animals. Animals subject to the microclimate of Burdur Lake are harmed by the application. Figure 8.

At the same time, high amounts of animal grazing activities carried out within the ecological area of the lake cause the destruction of vegetation, the deterioration of coastal landscape and water pollution (Anonymous, 2012). It is a must to carry out grazing activities at a certain distance from the lake and to apply a regime such as rotational grazing. Animal husbandry, accumulation of manure and the withdrawal of the lake and its feeding with wastewater have increased the mosquito population around the lake. Claystone dust coming out of the drying areas of the lake disturbs the surrounding settlements. In order to prevent dust formation in the withdrawn lake areas, a 15-20 cm thick layer of fertile soil should be poured into this area and these areas should be planted.

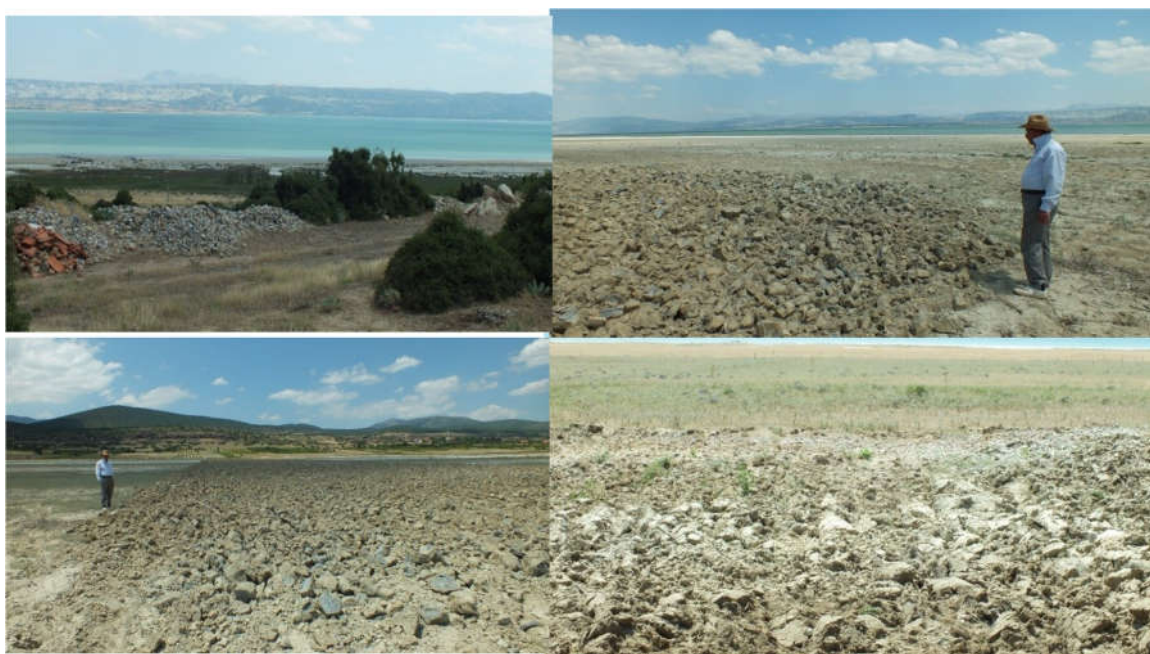
Figure 9: The dried areas around Burdur Lake are being ploughed by the surrounding villagers and turned into fields. Official institutions apply retribution instead of punishment. This practice encourages the occupiers. In some places, construction waste is dumped to turn it into the province's garbage dump.

The retaliatory fines applied to the land occupation areas around the lake are far from being deterrent. From time to time, due to the

intervention of political authorities, the implementation of these fines becomes difficult. Therefore, political authorities should not act in a way that encourages citizens who occupy treasury land and damage the natural structure.
